Case study: Bundle swap in crude unit

Case Study – Vacuum Residue

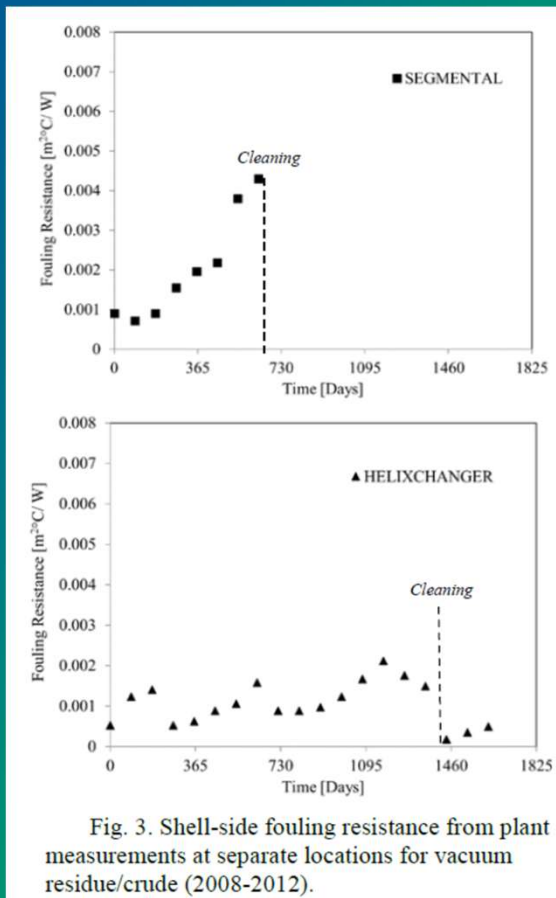
Service: Vacuum residue/desalted crude heat exchanger

- ✓ Highest fouling in the unit
- ✓ Cleaning required every 2 years
- ✓ Heat recovery below design after 3-6 months

- ✓ replacement with HELIXCHANGER®
- ✓ Vacuum Residue on shell-side to minimize piping changes

Cleaning cost saving equivalent to one new bundle cost

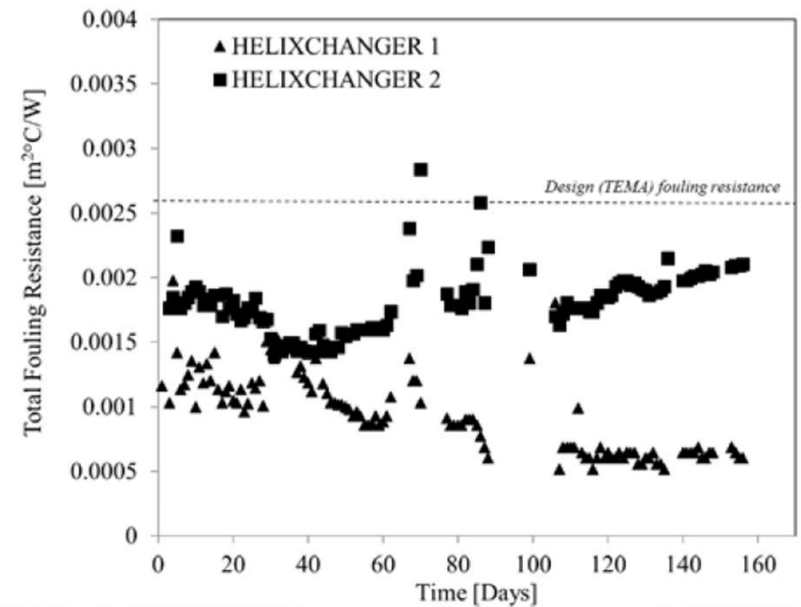
2 x Vac Resid (Shell Side) HCGO (Tube Side)

Fouling factor 0.0026 m²°C/W

Design Basis : 392 to 650 °F (11.6 MW)

Current : 330 to 650°F (16.2 MW)

39.65% Higher Duty

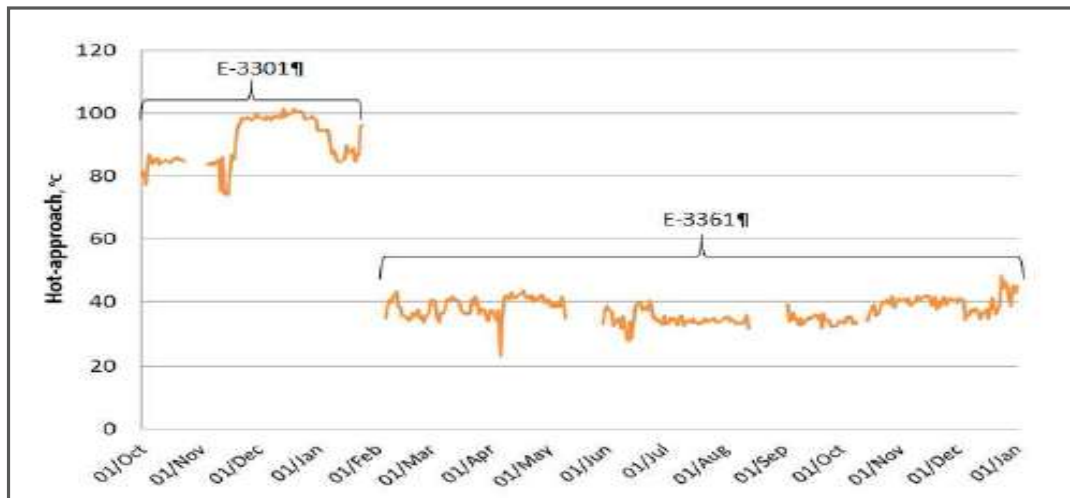
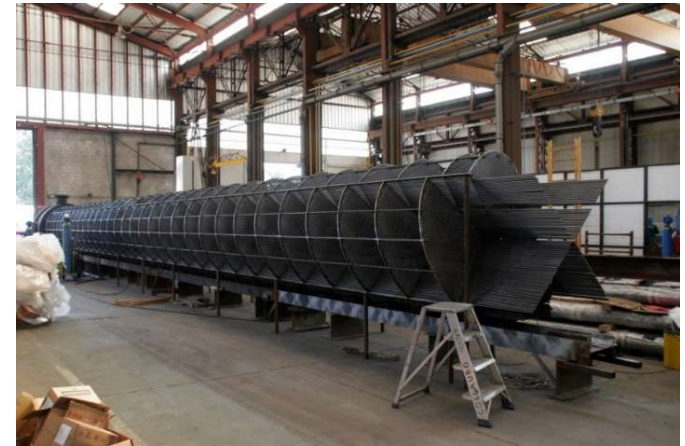
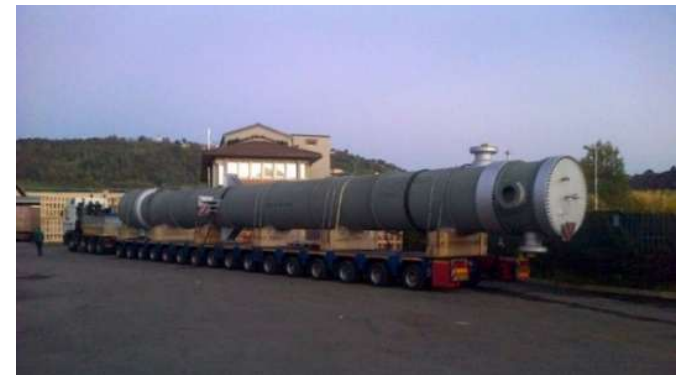
Problem: Large hot-approach temperature (HEA) in Texas Tower, E-3301, resulting in decreased energy efficiency of CCR Platformer. In the unit upgrade client wanted a technology that could guarantee a lower T approach

Solution: The Texas Tower was replaced with HELITOWER, E-3361, targeting a 35-40°C HEA

- 8 MM BTU/HR of energy savings
- HEA of 40C was achieved and maintained

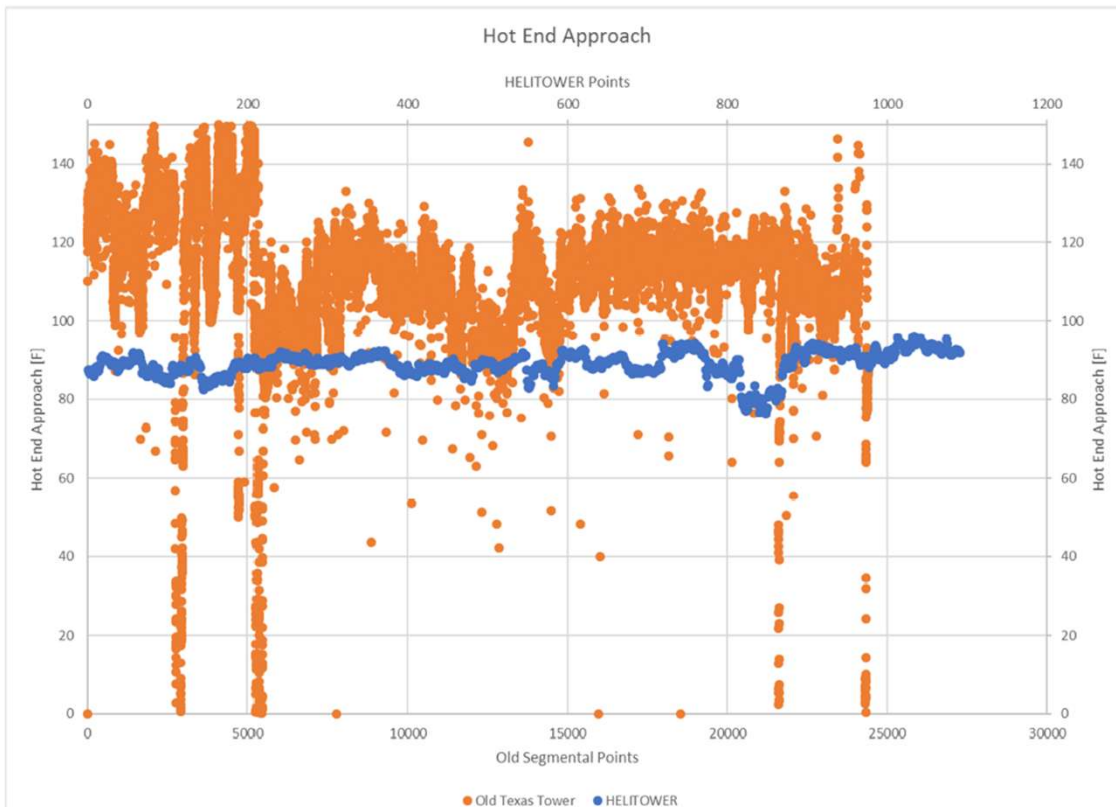
Old Texas tower	New HELITOWER
Data point		21-JUN-17 15:18:00	6/28/18 12:00 AM
Flow rate	BPD	12,268	12,501
	lb/hr	134,891	137,455
Feed in	F	133.40	133.50
Effluent in	F	911.73	908.20
Feed out	F	795.60	819.98
Effluent out	F	237.00	217.10
MTD	F	94.00	73.60
Hot end approach	F	116.13	88.22
Average duty	MMBtu/hr	78.50	82.68
